Магістерська дисертація
на здобуття ступеня магістра
за освітньо-професійною програмою «Динаміка і міцність машин»
зі спеціальності 131 «Прикладна механіка»
на тему: «Аналіз довговічності та тріщиностійкості рядового шпангоута
вузькофюзеляжного літака»

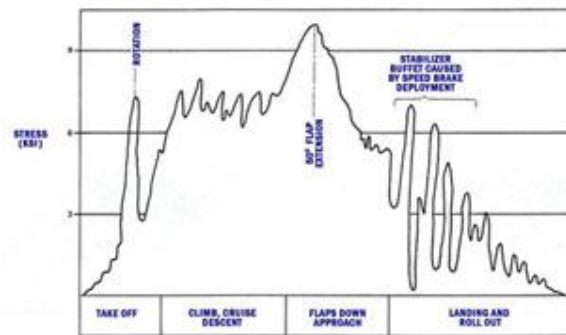
Figure 1.2.12 Diagram of the horizontal stabilizer load spectrum
(View Large Diagram)

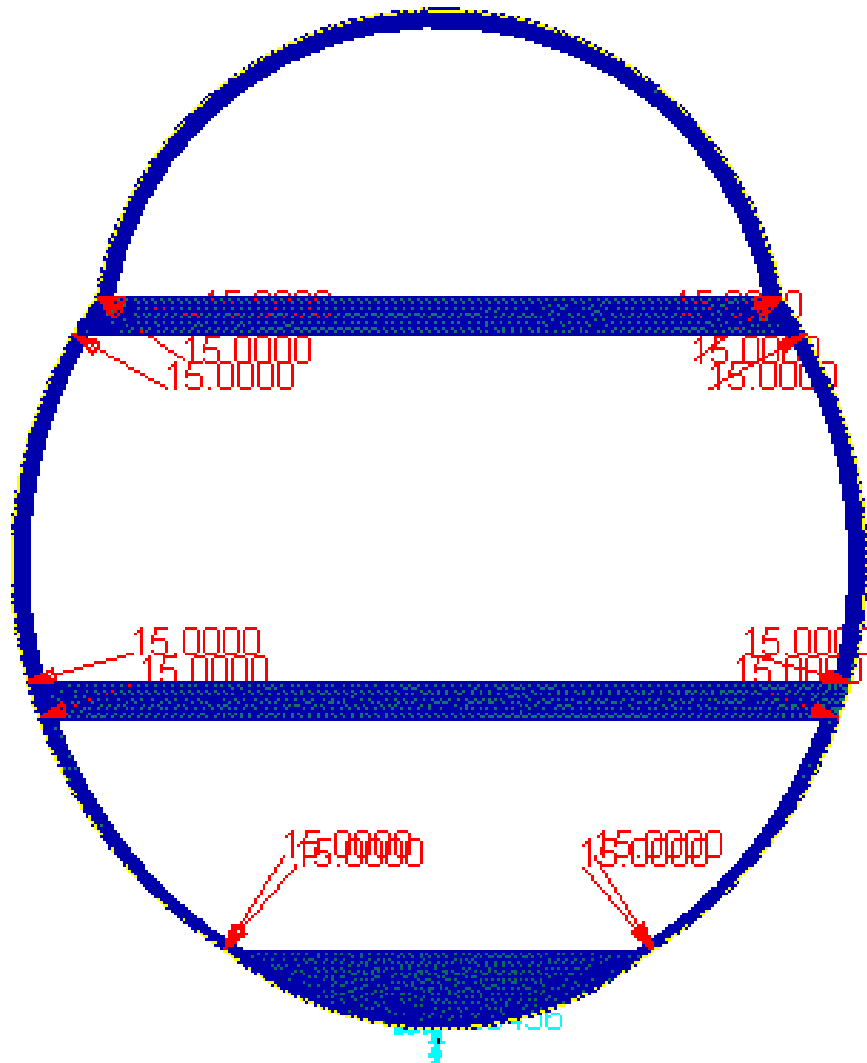
Figure 4.2.1 – Fuselage frame FEM uniform pressure load.

For a non-cylinder fuselage, pressurization makes the biggest impact to its stress state. Thus, simplification of loading will not significantly change the structure's response. It was substantiated earlier that pressure level has to be equal 15 psi. The model with the applied uniformly distributed pressure is shown.

One node was fixed in order to avoid mechanism.

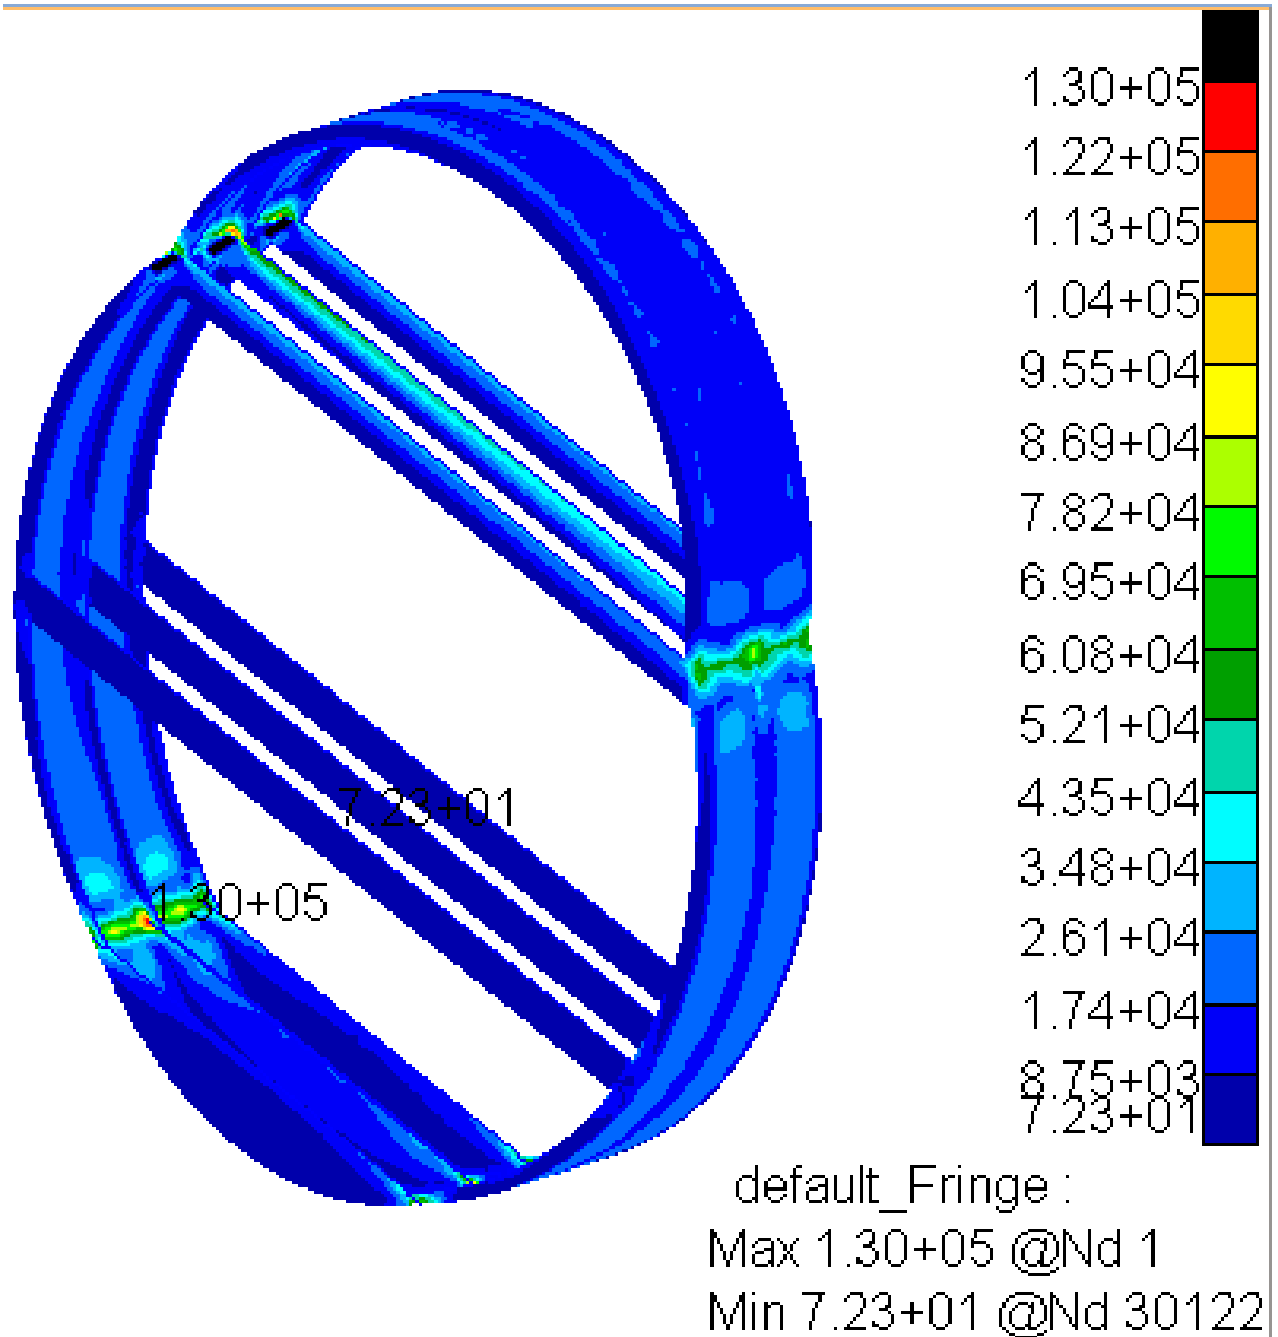
Figure 4.3.1 – First stage (initial model) FEA

Initial model analysis shows high Von Mises stresses due to inappropriate rigidity distribution, which leads to stress concentration. Second analysis iteration is required.

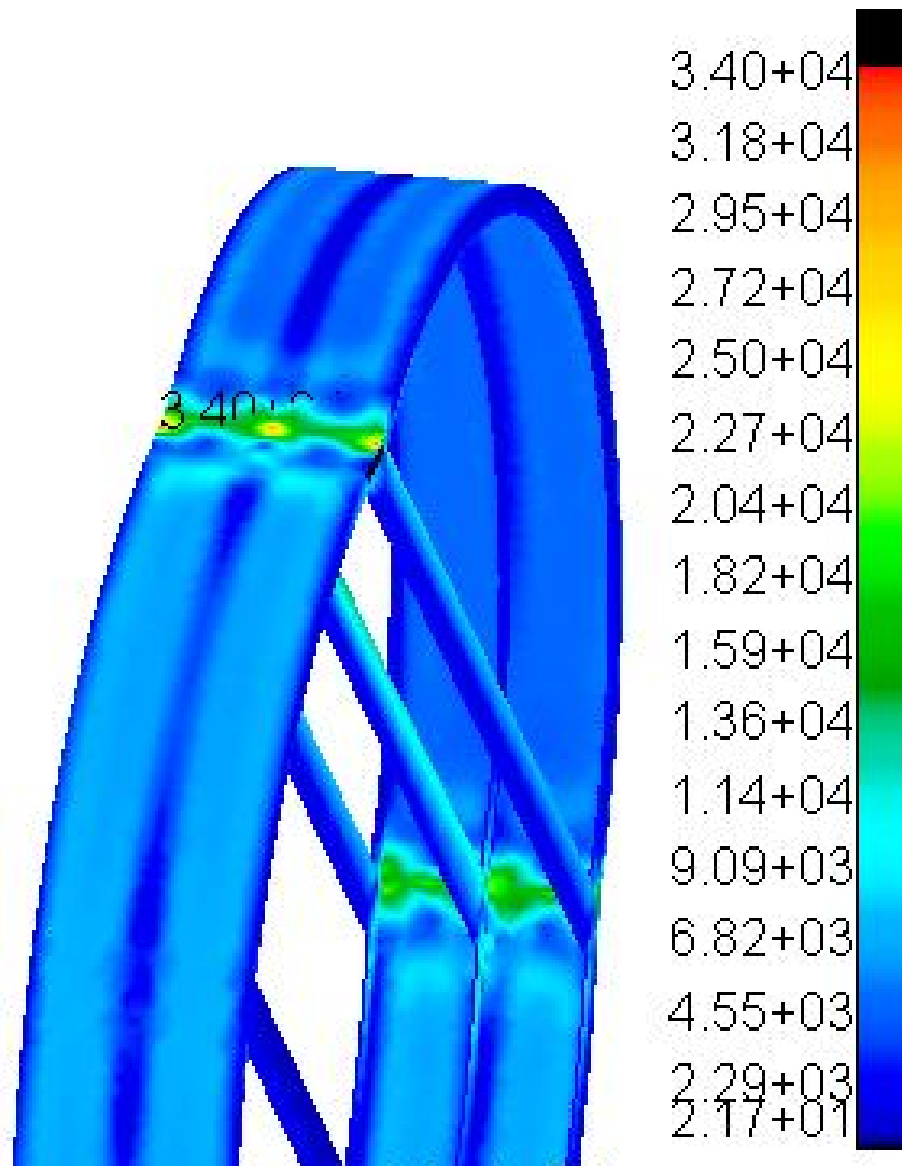
Figure 4.3.2 – Third (final) Stage static analysis

Maximum stress lower then the allowable stress of 34,1 ksi

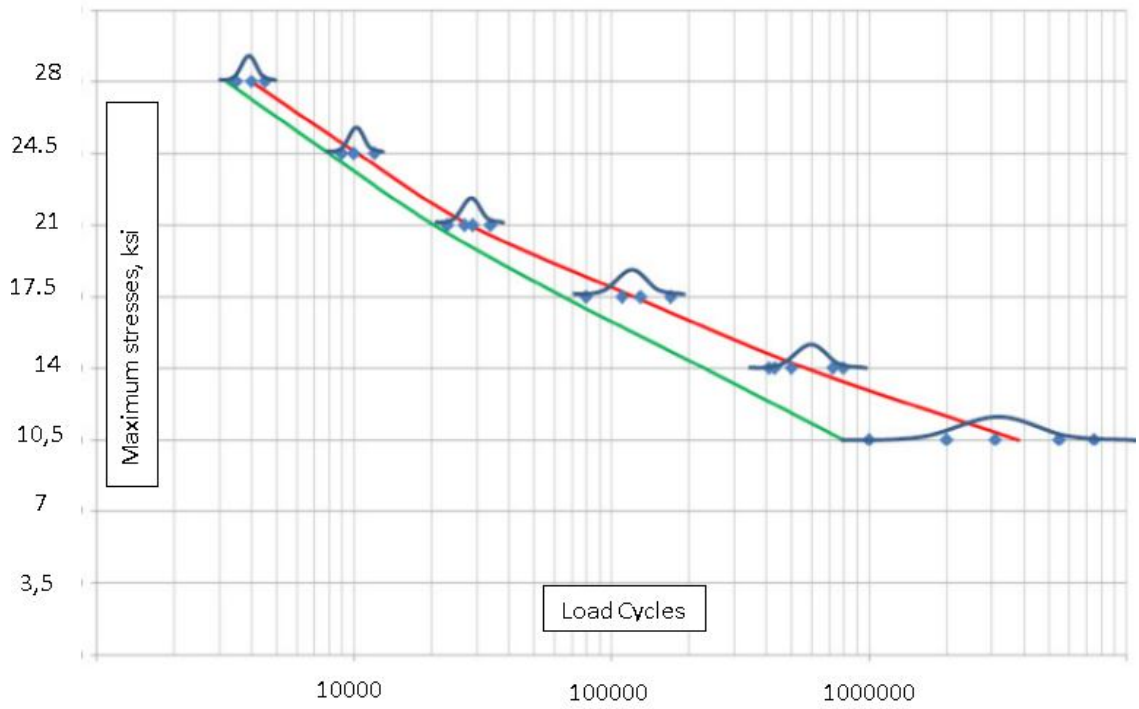
Figure 5.2 - Fatigue Analysis Result

Stress, ksi	K	Confidence	Basis	Cycles
17	3	95%	95%	104532
